DEPARTMENT OF TRANSPORTATION

Contract #: 04-0120F4Cty: SF/ALA Rte: 80 PM: 13.2/13.9File #: 73.28**WELDING INSPECTION REPORT****Resident Engineer:**Pursell, Gary**Address:** 333 Burma Road**City:** Oakland, CA 94607**Report No:** WIR-010950**Date Inspected:** 19-Nov-2009**Project Name:** SAS Superstructure**OSM Arrival Time:** 800**Prime Contractor:** American Bridge/Fluor Enterprises, a JV**OSM Departure Time:** 1800**Contractor:** HoChang, Korea**Location:** Unyang, Korea**CWI Name:** Sang Ho Kwak**CWI Present:** Yes No**Inspected CWI report:** Yes No N/A**Rod Oven in Use:** Yes No N/A**Electrode to specification:** Yes No N/A**Weld Procedures Followed:** Yes No N/A**Qualified Welders:** Yes No N/A**Verified Joint Fit-up:** Yes No N/A**Approved Drawings:** Yes No N/A**Approved WPS:** Yes No N/A**Delayed / Cancelled:** Yes No N/A**Bridge No:** 34-0006**Component:** Pier E2 Bearing and Shear key**Summary of Items Observed:**

The following report is based on METS observations at HoChang Machinery Industries (HMI). On this date the Caltrans Quality Assurance (QA) inspector, Dong J. Shin arrived at HoChang Machinery Industries (HMI) located at Unyang and Onsan Korea and Korea Precisi

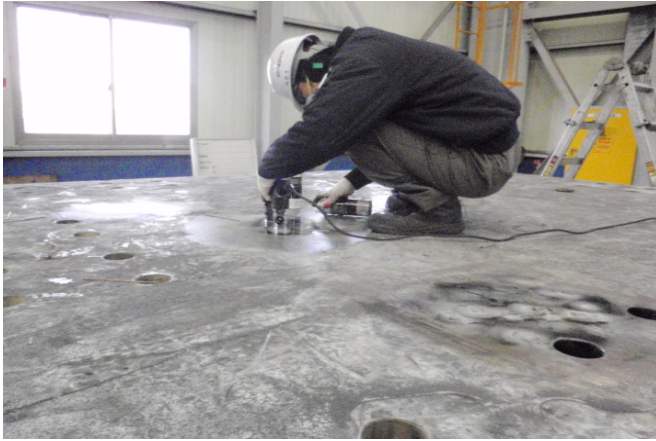
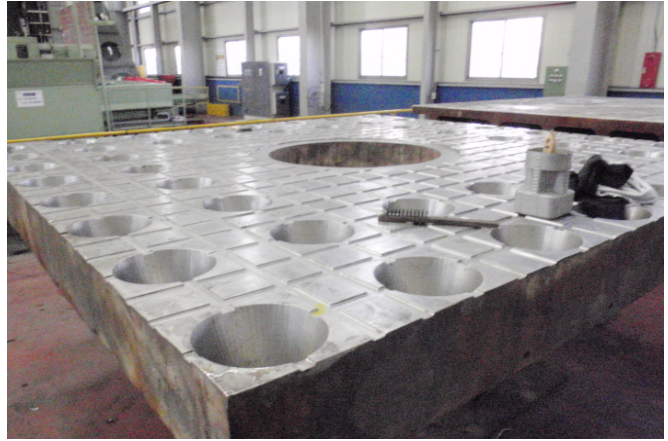
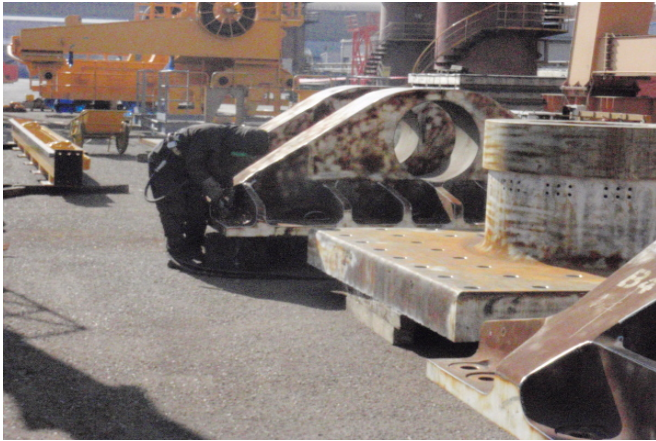
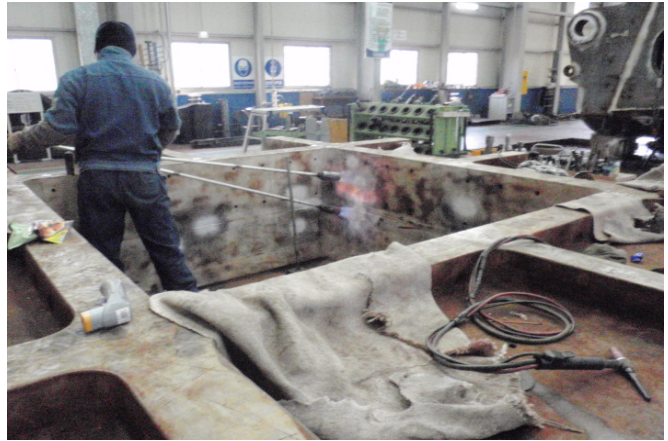
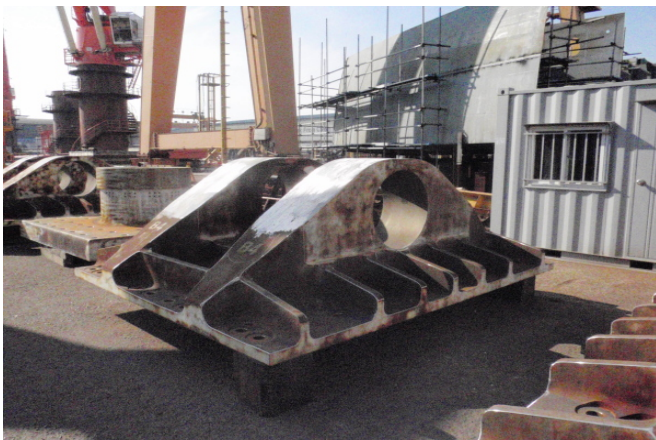
Samjeon NDT technician Mr. D. Y. Whang performed final MT after final machining and minor defect repair of Bearing Top Housings and Shear Key housings. QA inspector checked the following items prior to testing: Calibration Date, AC lifting power, and Pie gauge sensitivity. MPT used Yoke probe with wet visible method.

Samjeon NDT technician Mr. G. T. Kim performed UT at minor repair areas on Bearing Top Housings and Shear Key Housings. QA inspector verified the following items prior to testing: UT Calibration date, calibration date and DAC curve, transducer size and frequency. Transducers Used: Straight Beam: 24mm dia. 2MHz, Dual Straight beam: 6 x 10mm 4MHz and miniature angle: 8 x 9mm 4 MHz 45°.

On this date, HMI Qualified welder Mr. O. J. Park performed minor repair welding on Bearing Top Housing, Shear key Stub and Shear Key Housing. QA inspector and HMI QC Inspector verified welding parameters prior to start welding. Welding process utilized was Gas Tungsten Arc Welding (GTAW) with ER70S-6 with diameter 2.4mm rod manufactured by Hyundai Steel, Brand name ST-50.6 with 100% Argon gas. QA inspector verified welding parameter range was 15-17 volts, 200-245 amps, travel speed 74-89mm/min, Gas flow 12-15litre/min., preheat temperature over 150°C and interpass temperature of less than 250° C. After completing repair welding, HMIC increased the preheat to 300°C for PWHT and covered by Heat blanket for slow cool down. All of welding parameters comply with approved welding procedure specifications No A-T-Z1Z1-147.
